Report Number: PL1591-2

Test Report

DEVICE TESTED: AusProof 1.1 kV 60 A Plug and Receptacle
Sample identification numbers:
Job # 17/0069, S.ID. 1708A7 and S. ID. 1708A8

TEST SPECIFICATION: Clauses 3.3.10 and 3.3.11 of AS/NZS 1299:2009
incorporating amendment 1.

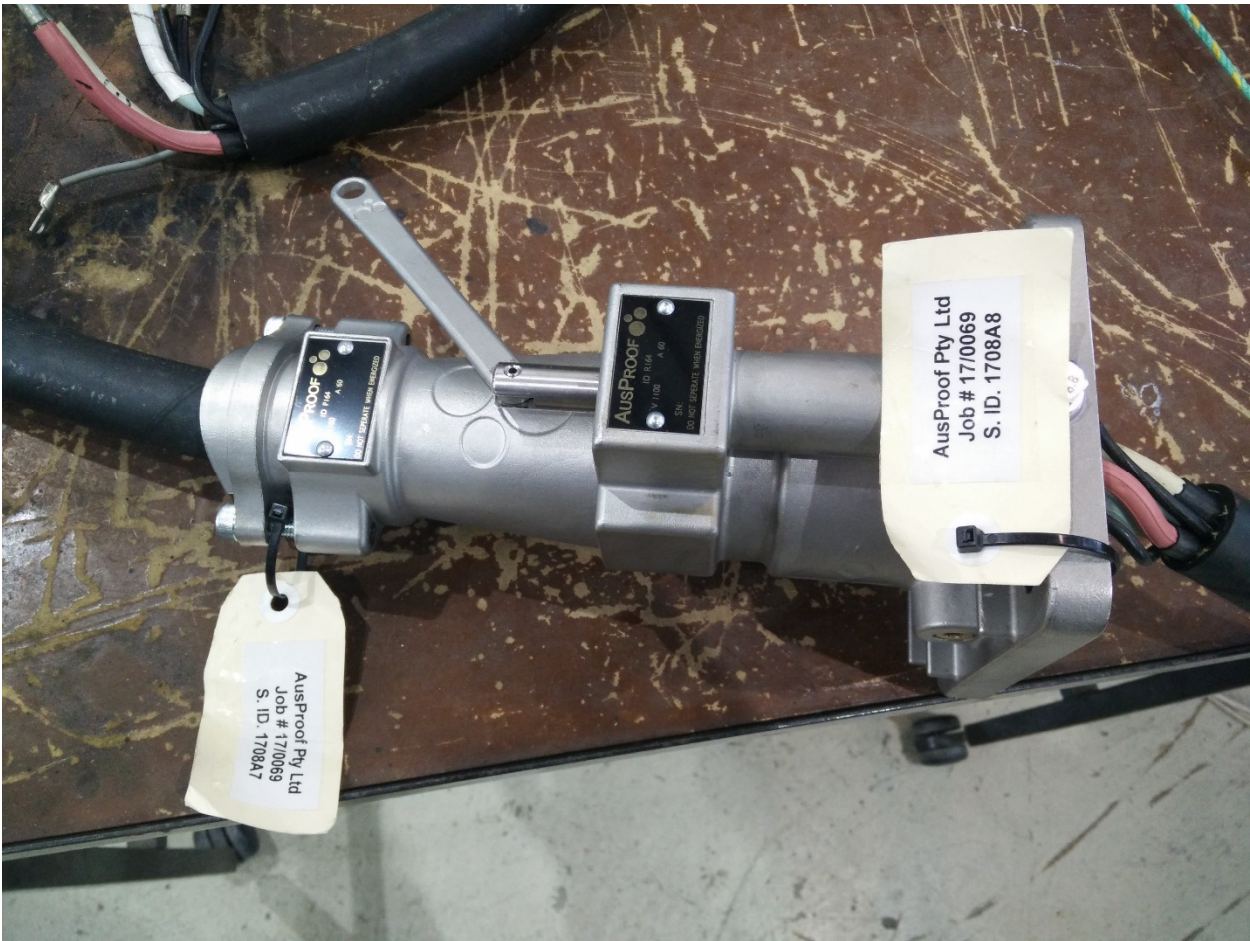
The sample device assembly tested was terminated with Client supplied cables, type 10 mm² type 241.1 mining cable.

Test sample assembly

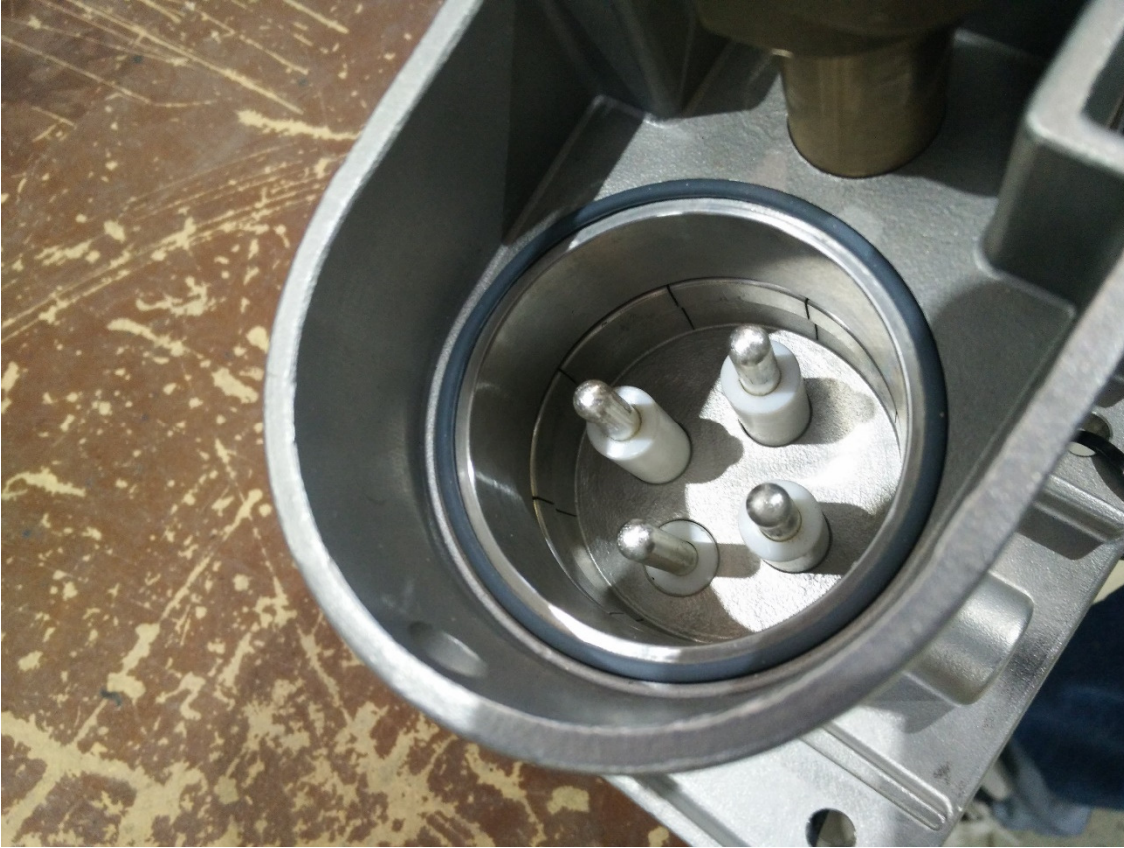
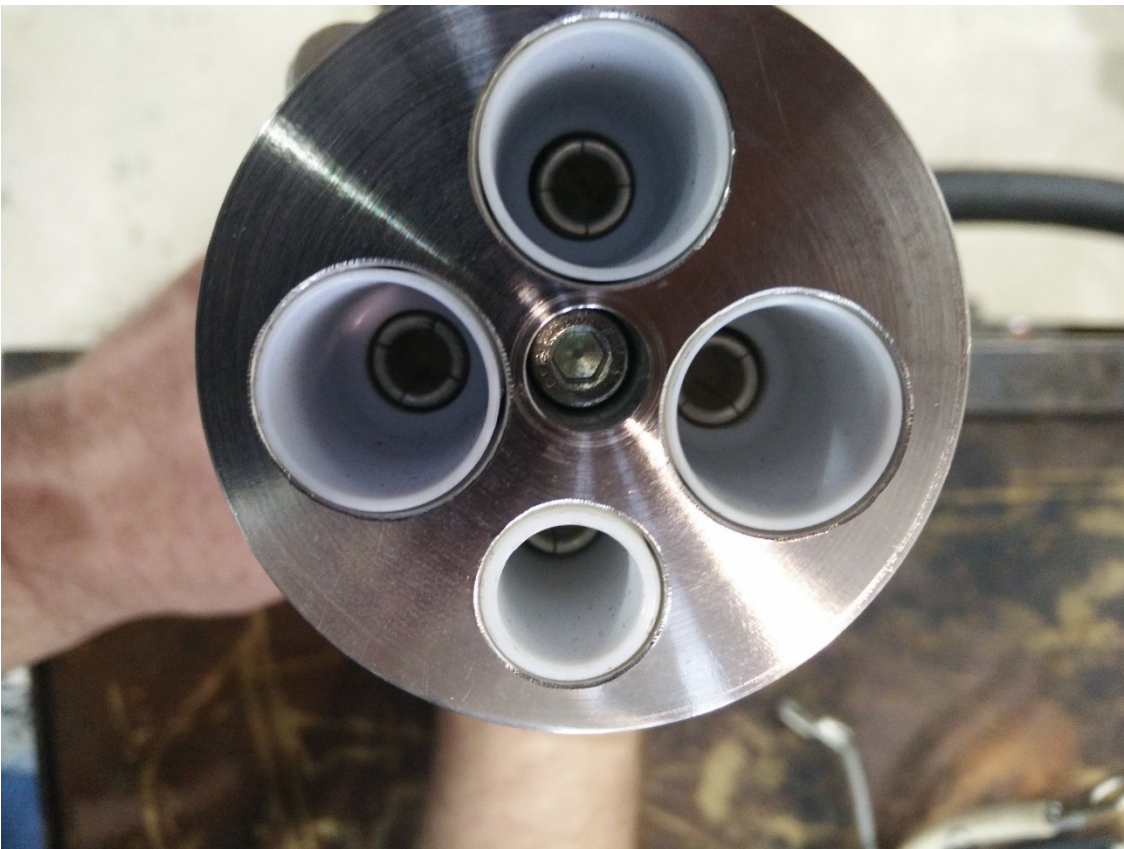
After two applications, there was no visible disturbance, pitting or burning.

The test sample complied with the requirements of the test specification.

After Clause 3.3.10 test

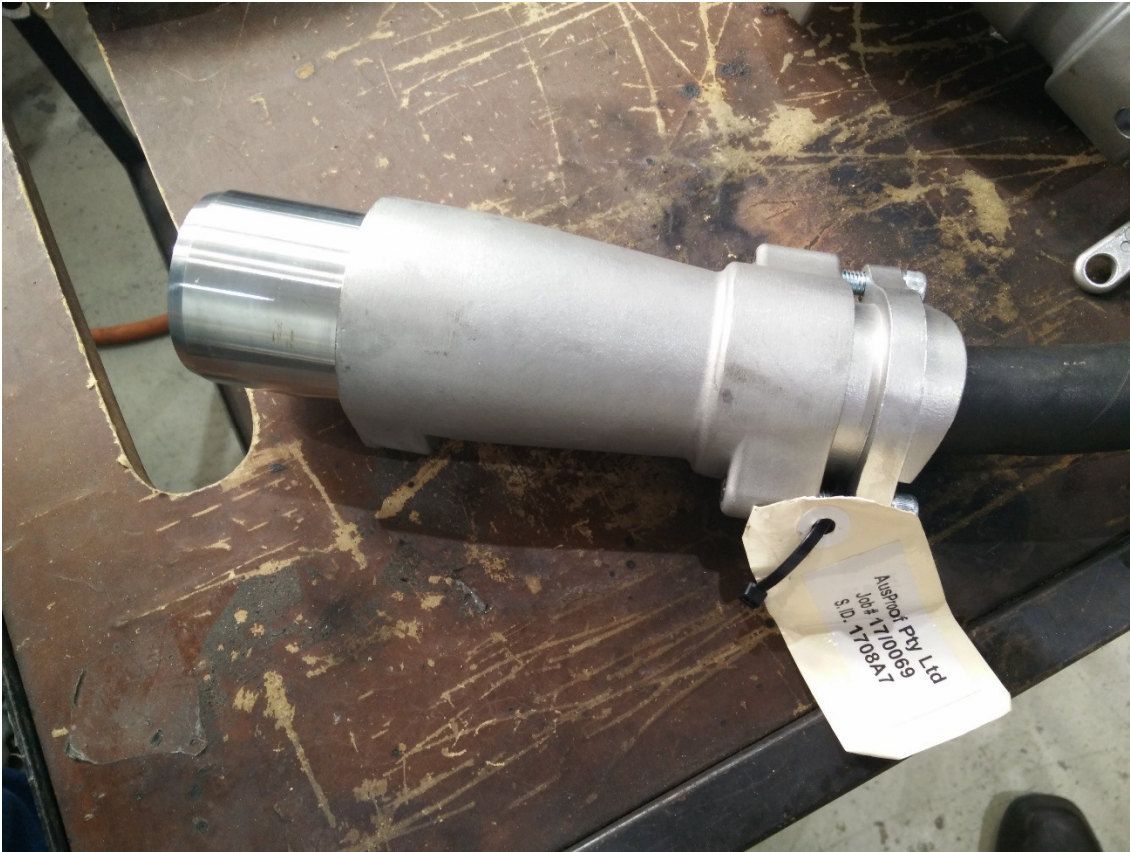
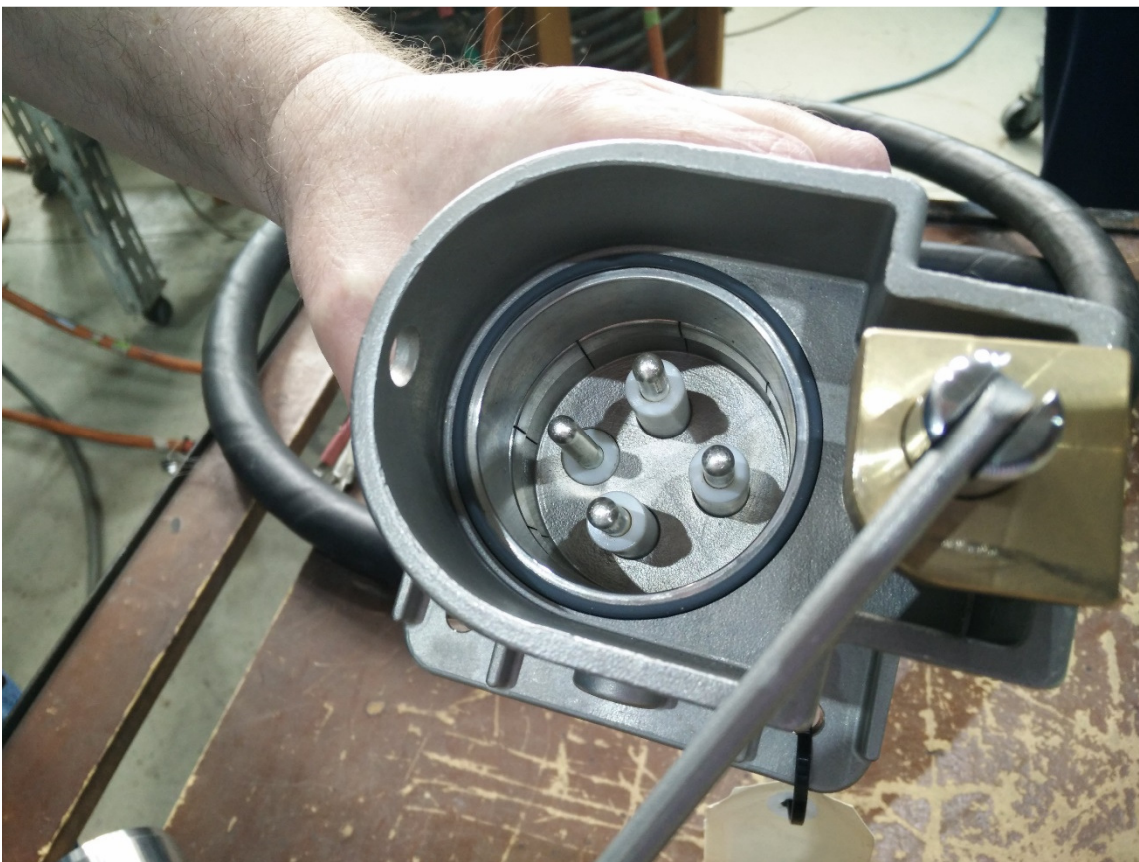
After 2 applications the measured continuity was 0.0007 Ω which is less than the allowed maximum of <0.01 Ω .

The test sample complied with the requirements of the test specification.

After clause 3.3.11 test
